U.S. DEPARTMENT OF
ENERGY

Legacy
Management

2021 Annual Site Inspection and Monitoring Report for Uranium Mill Tailings Radiation Control Act Title II Disposal Sites

December 2021

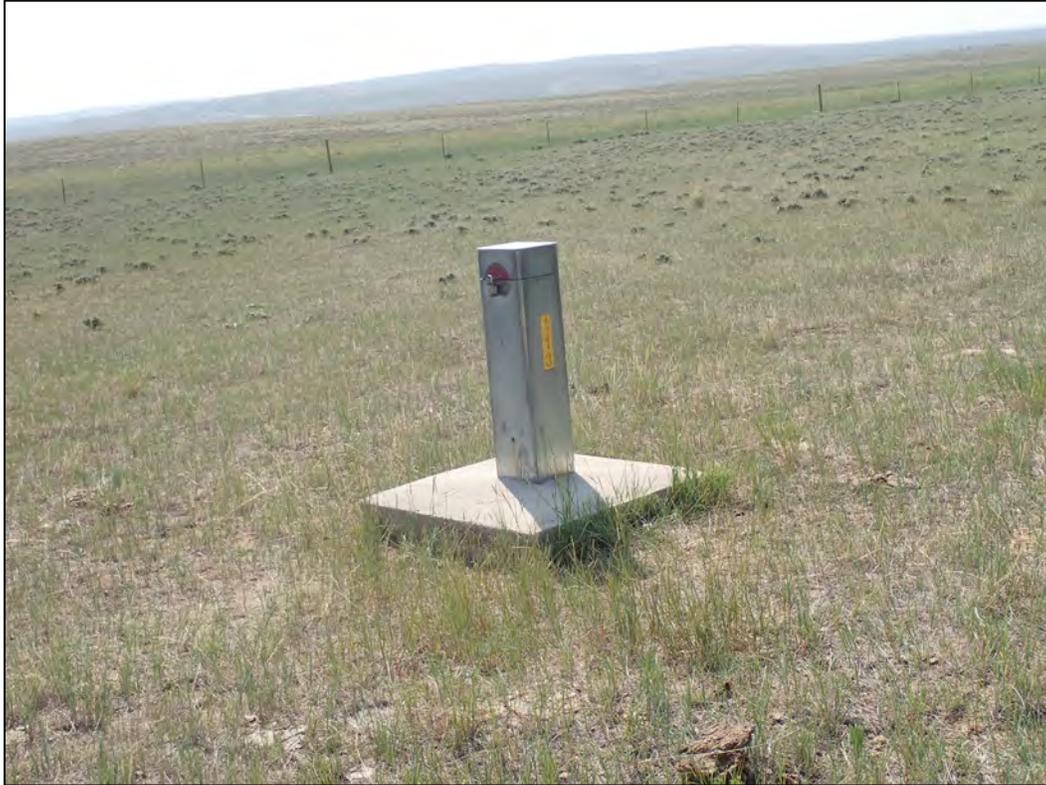
PL-5. Monitoring Well 113-DC

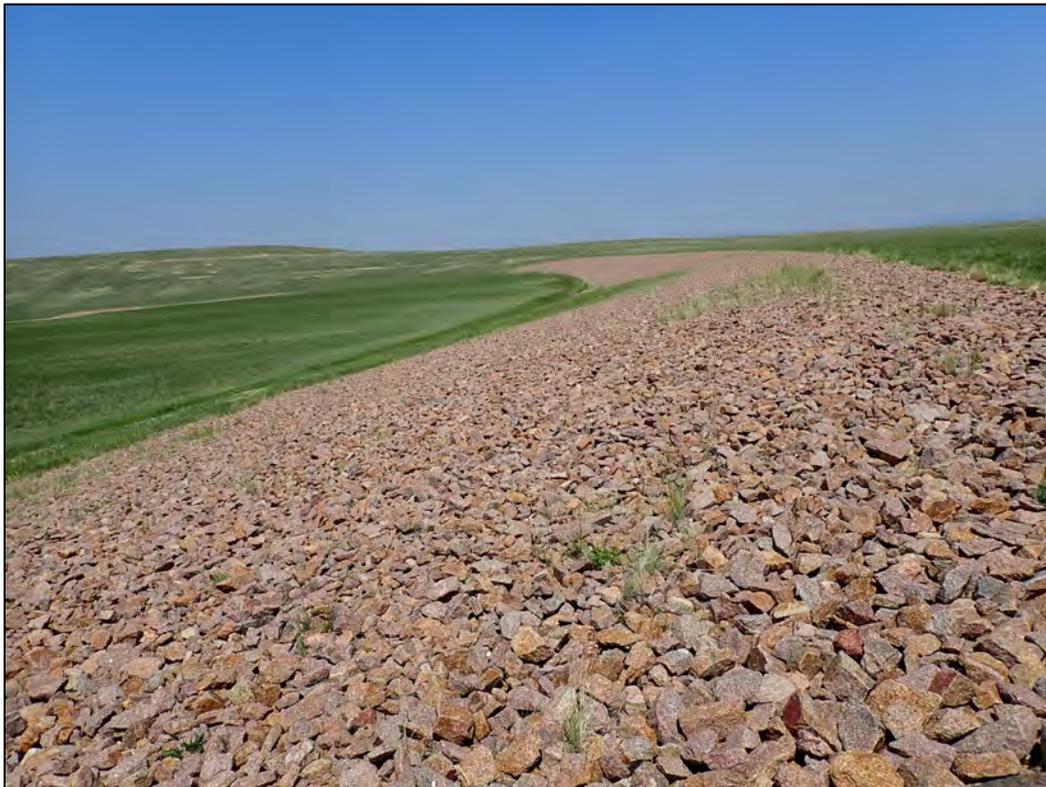
PL-6. Disposal Cell Riprap Between Upper and Lower Level

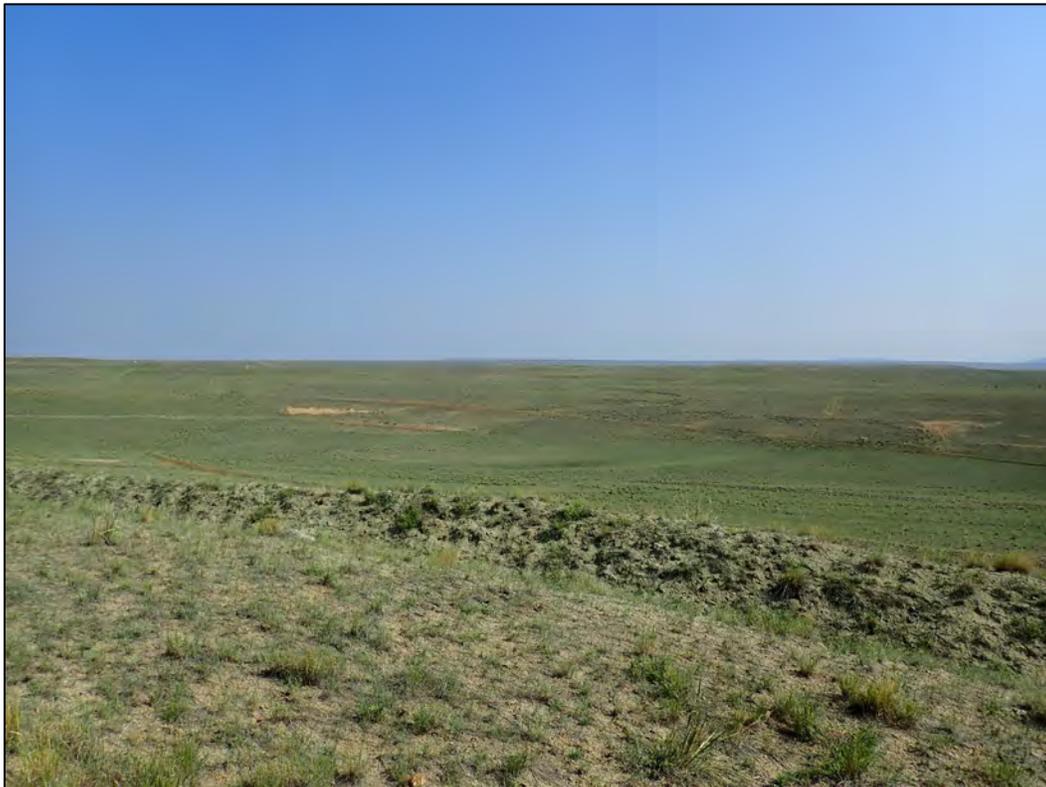
PL-8. Basin, Southeast Corner of Site

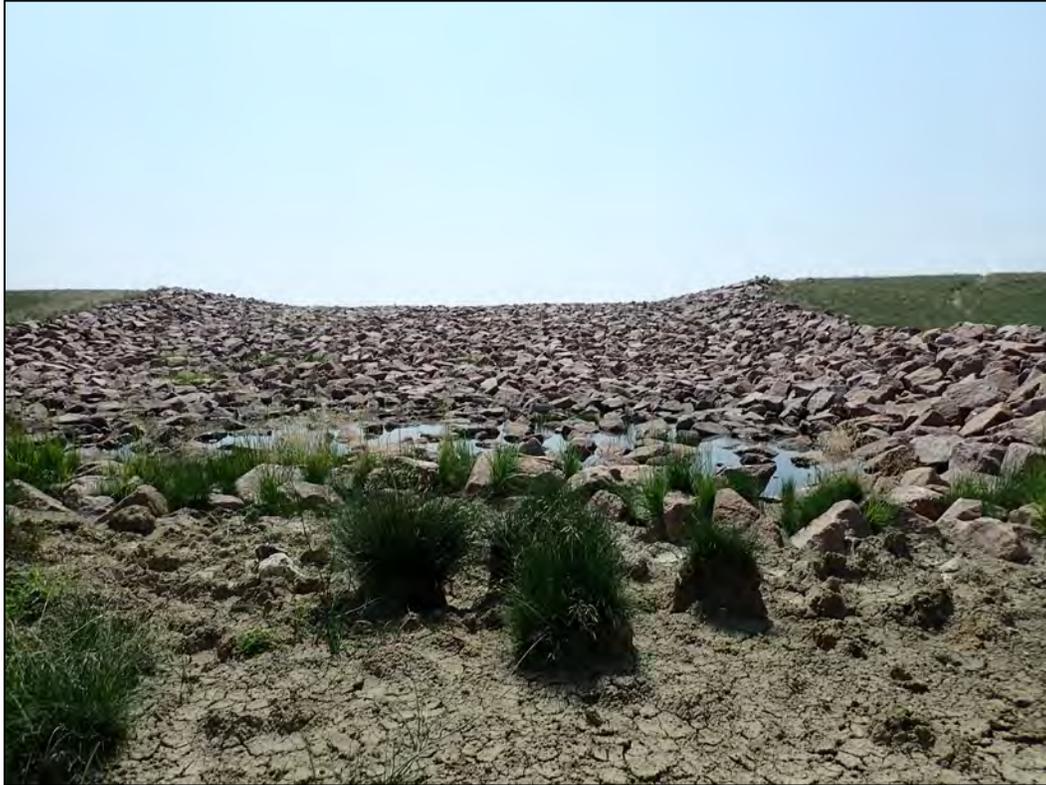
PL-9. Base of North Swale Discharge Point

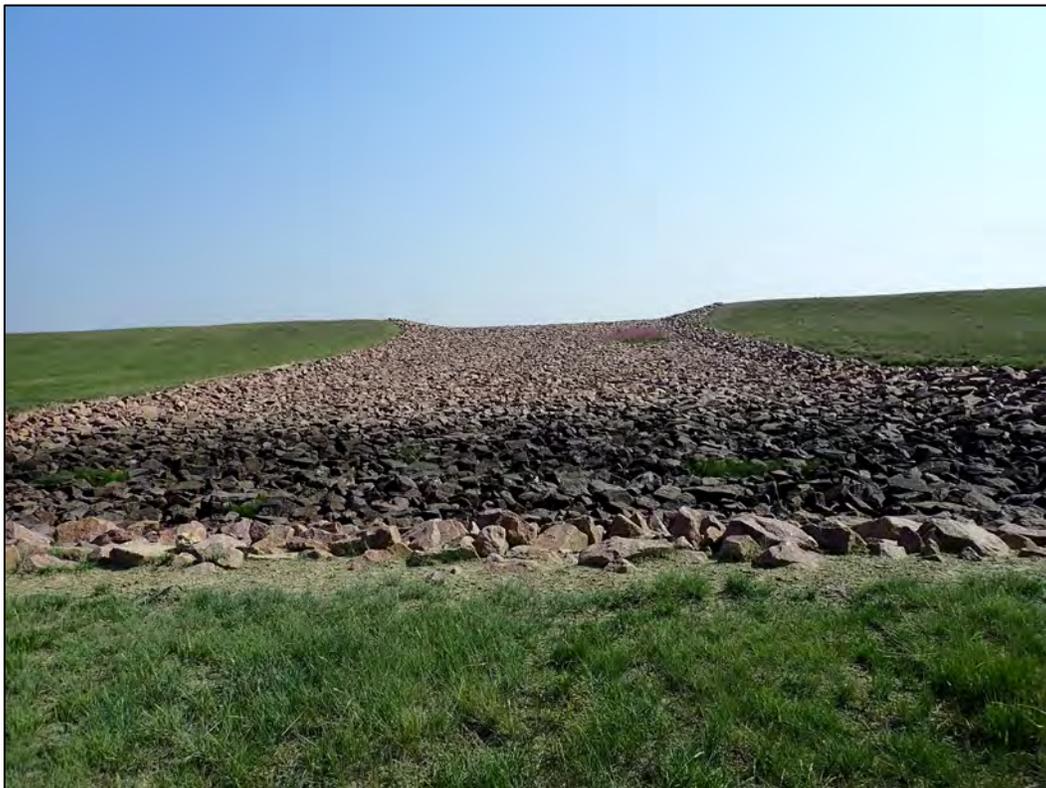
PL-10. Base of South Swale Discharge Point

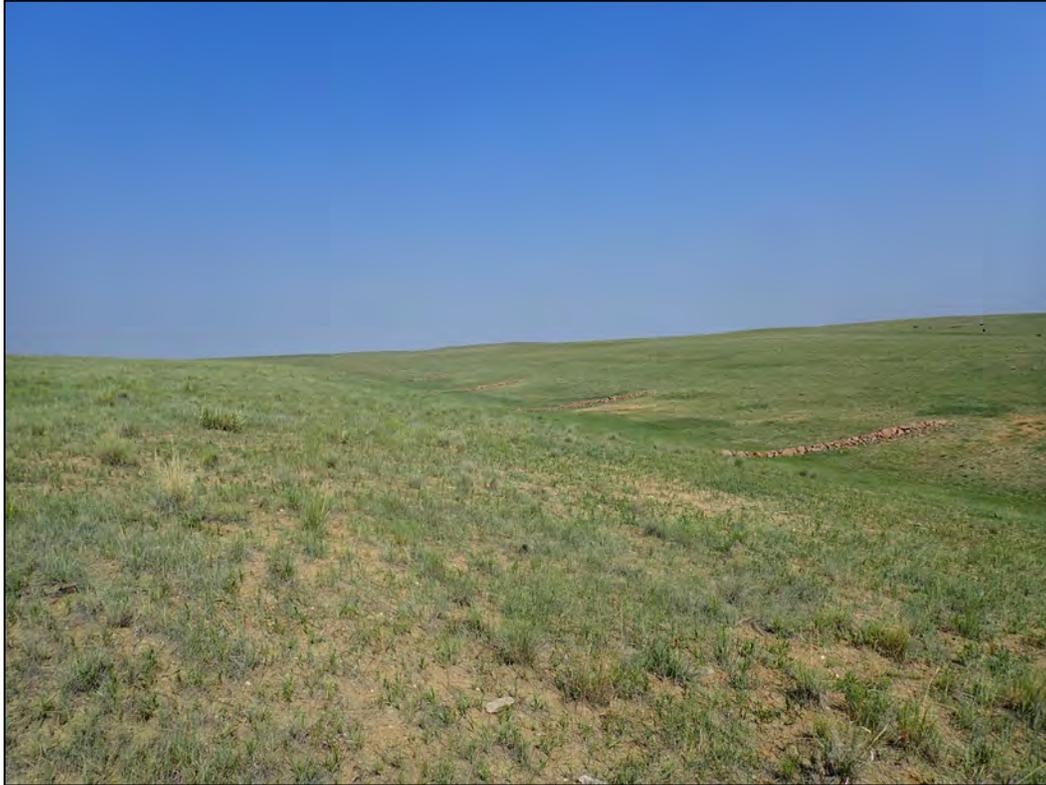
PL-11. Rock Check Dams, Southeast Corner of Site

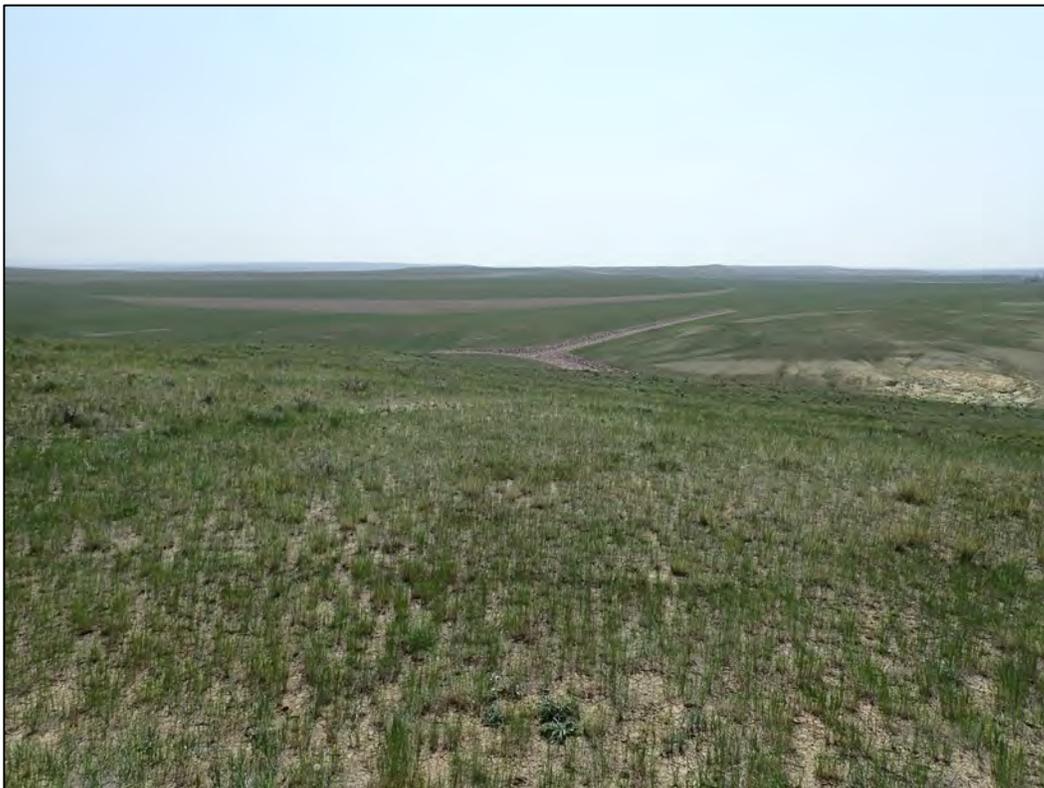
PL-12. Western Drainage Feature

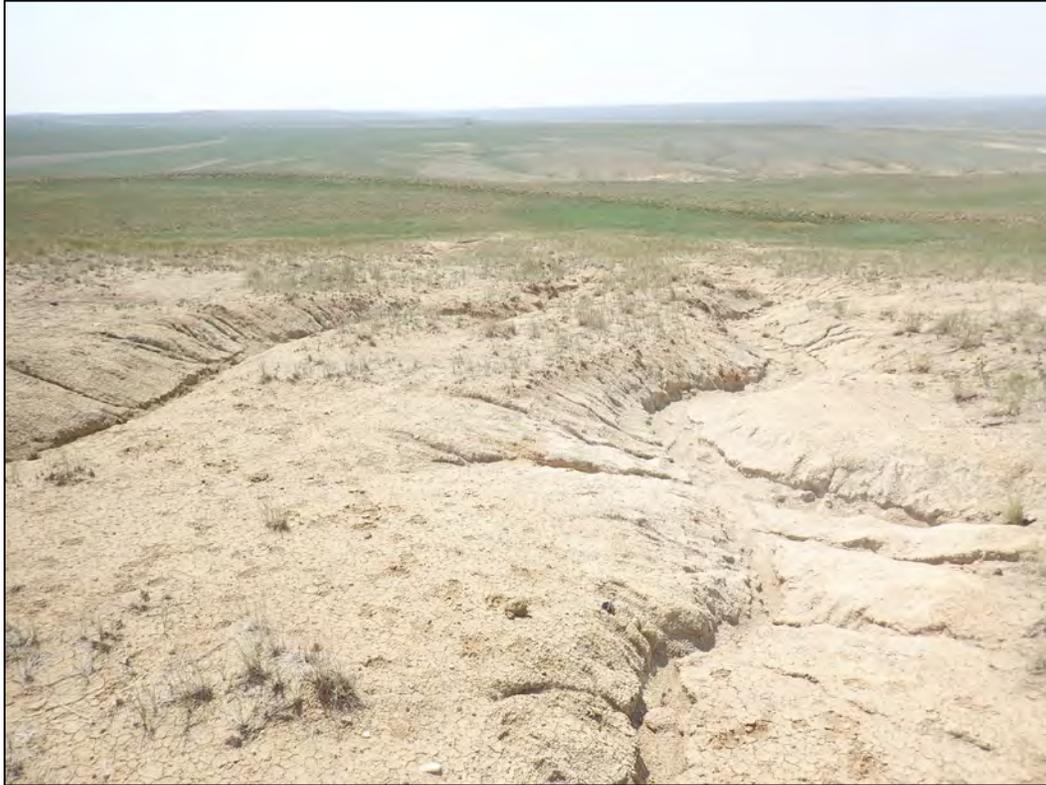
PL-13. Erosion Feature, Western Edge of Site

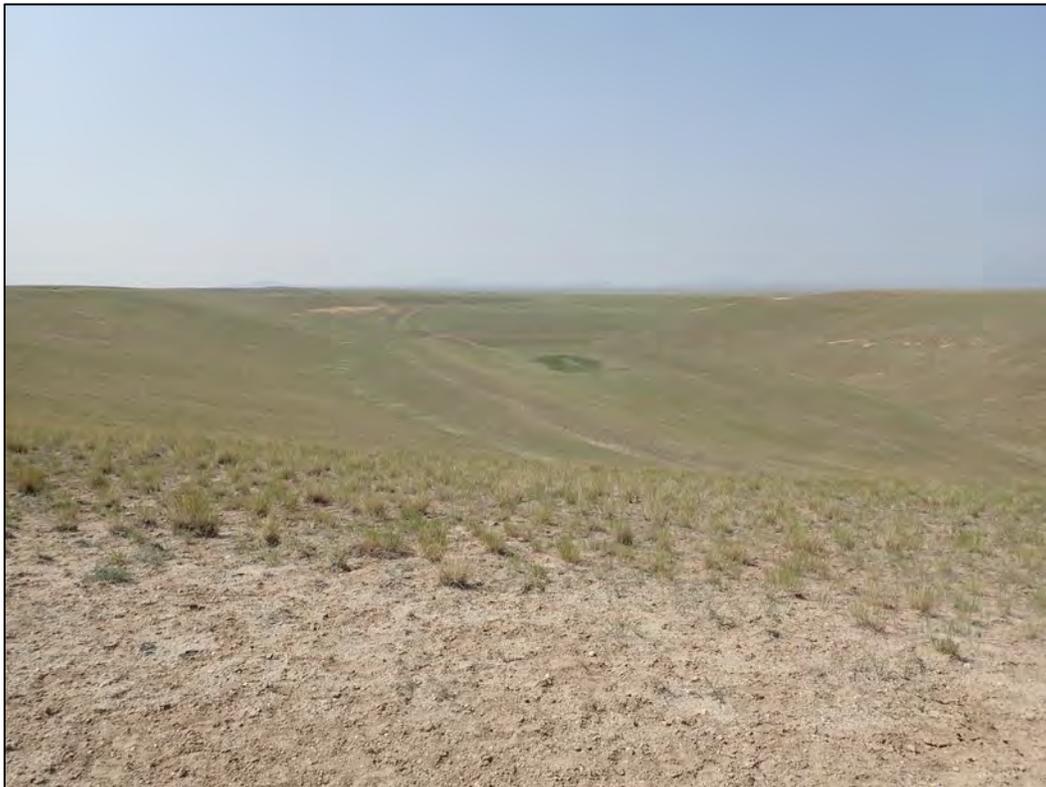
PL-14. Pit 4 and Wetland Area

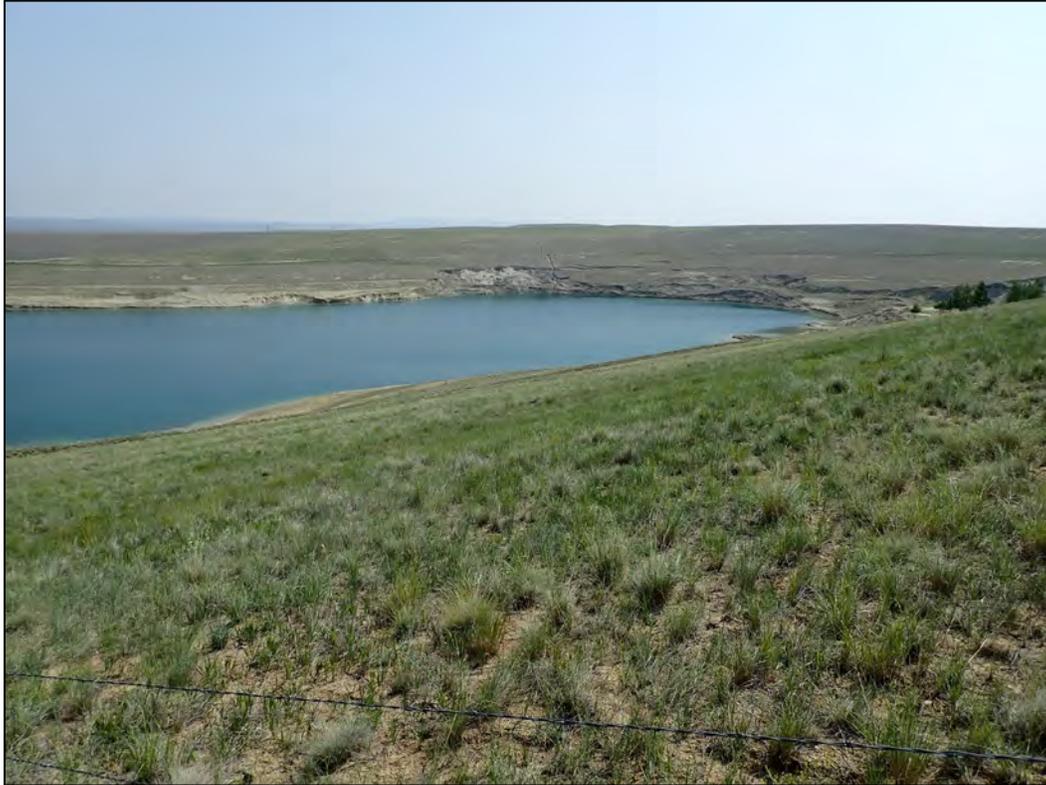
PL-15. Shirley Basin North Pit Lake
